OSLO S/SWITCHING STATION

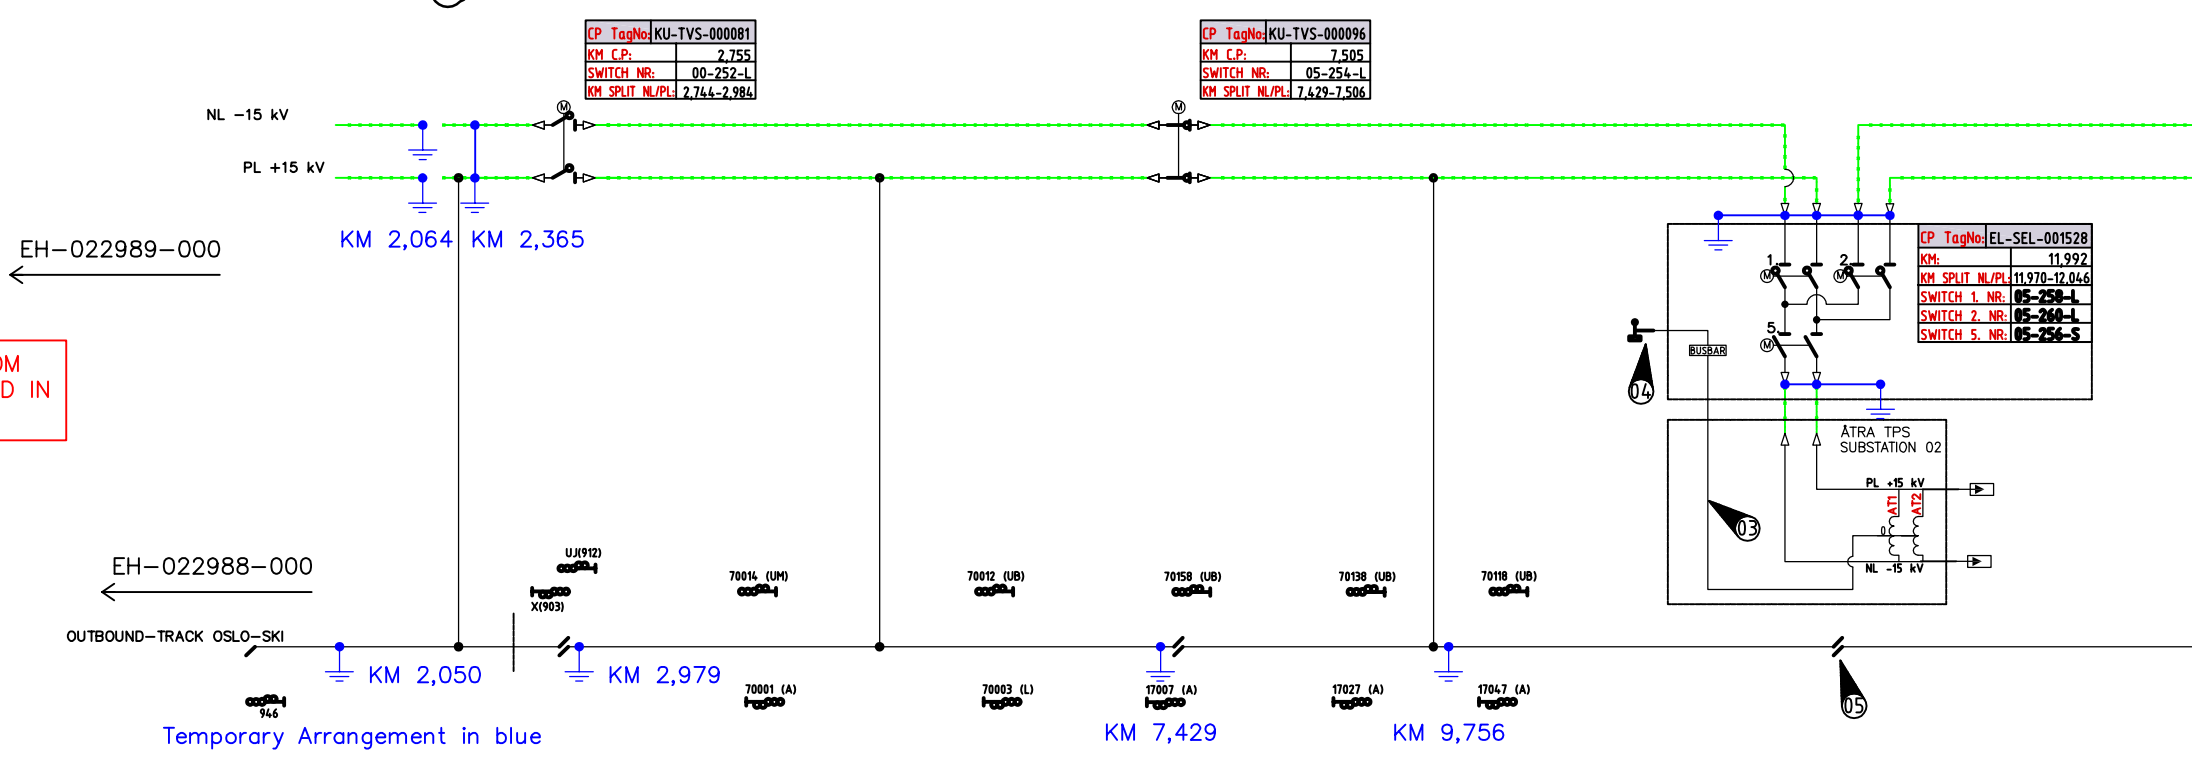
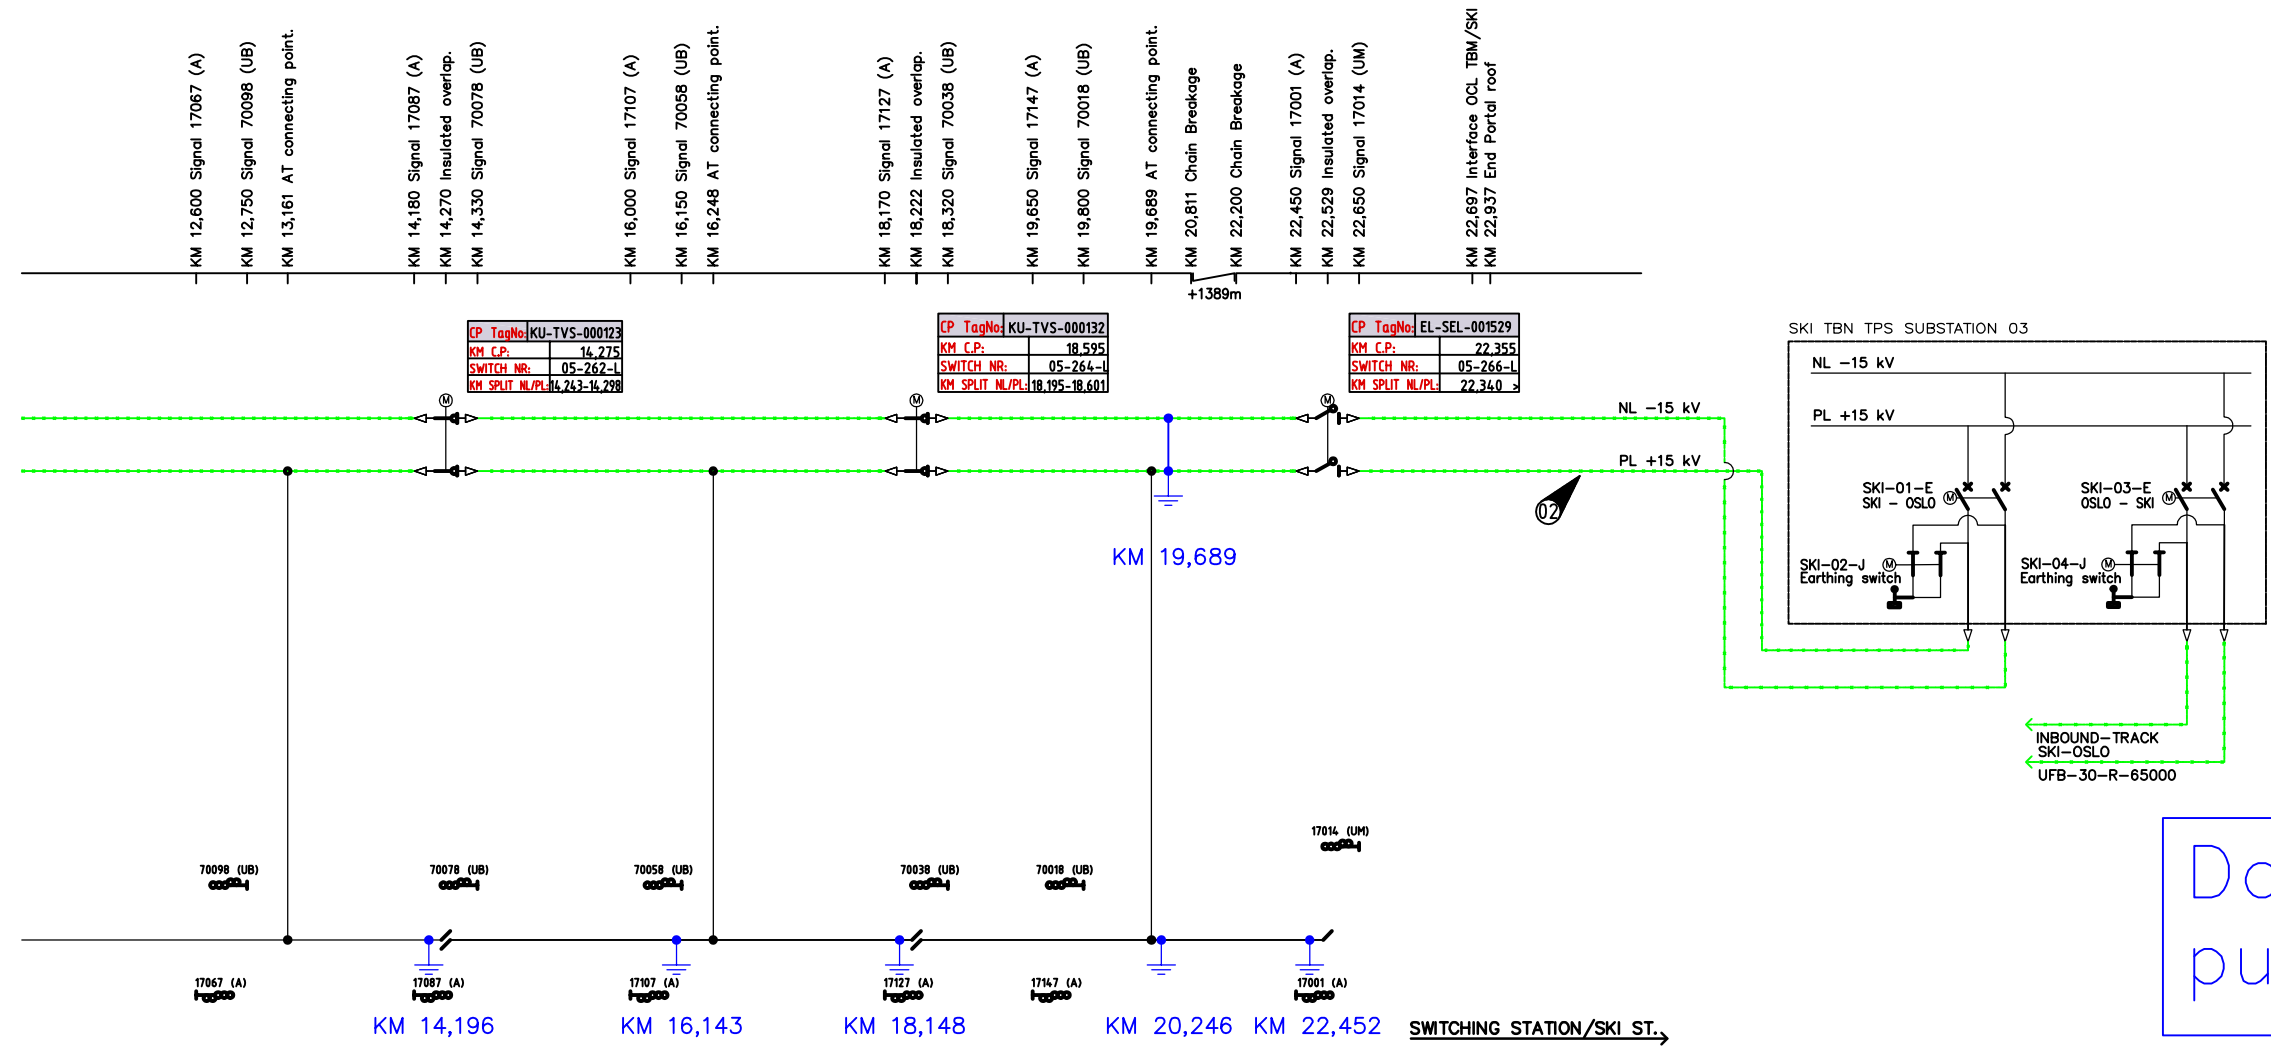
RETURN CABLES FROM ICHA NOT CONNECTED IN EITHER END

- REMARKS:
- Auto transformers is located in open air by Asland.
  - All switch arrangement are placed in High-Voltage room in Cross Passages or Technical buildings.

- Positive and Negative feeders as uninsulated conductors in the tunnel arc.
  - Surge arresters mounted before entering the tunnel.
  - Short circuit indicator on all overhead contact line sections.

- All km for Outbound refers to chainage for Outbound track.
  - Divisions and interfaces for the work-areas have not been decided.
  - Name of the switches at Oslo and Ski substations are not EPC TBM's responsibility, and are not valid.

- 01 Coupling point in Oslo S Interconnecting hall A. Interface TPS: EPC Oslo S/TBM.  
 02 High voltage cables for NL and PL, 2 X 400 mm<sup>2</sup> in cable ducts.  
 03 Return conductor 4 x 240/61 mm<sup>2</sup> connected to busbar. For details: EK.800230-000  
 04 Connections to running rail with Cu 95 mm<sup>2</sup>.  
 05 The insulated overlap is not relocated with the optical signals.  
 06 EPC Oslo S/D&B responsibility.
